R140.17/UK/01 - 07/2014

# R140.17 Disassembly/assembly recommendations

CITROËN: Jumper (I and II), Relay (I and II)

# **IDENTIFICATION OF NTN-SNR WHEEL KIT R140.17**

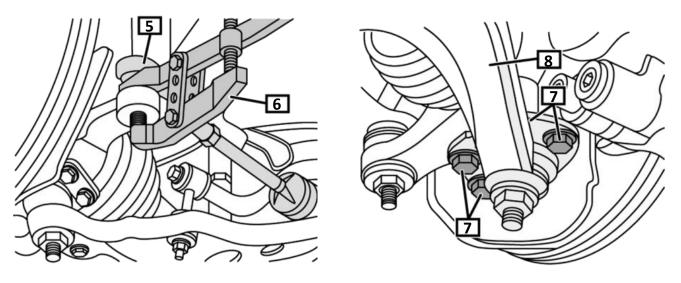
# 7) Use a ball joint splitter to remove the steering ball joint from the stub axle (no.5)

Special tool required: Ball joint splitter (no.6): OE 1847038000

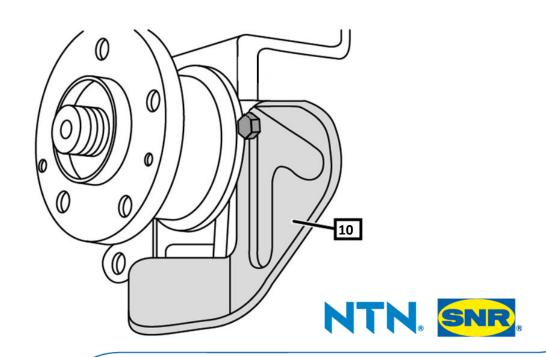
- 8) Remove the bolts from the lower joint (no.7) to release the control arm (no.8)
- 9) Remove the lower ball joint from the stub axle
- 10) Remove the back plate (no. 10)

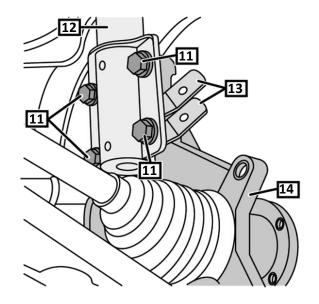
- 11) Remove the bolts from the strut (no.11)
- **12)** Separate the strut from kingpin (no.12) and (no.14)
- 13) Remove the kingpin (no.14)
- Remove the brake line bracket 14) (no.13)
- 15) Carry out the bearing replacement
